**Tree Inventory and Preservation Plan Report
50 Stephanie Street
Toronto, Ontario**

20 August 2025

KUNTZ FORESTRY CONSULTING INC Project P4605

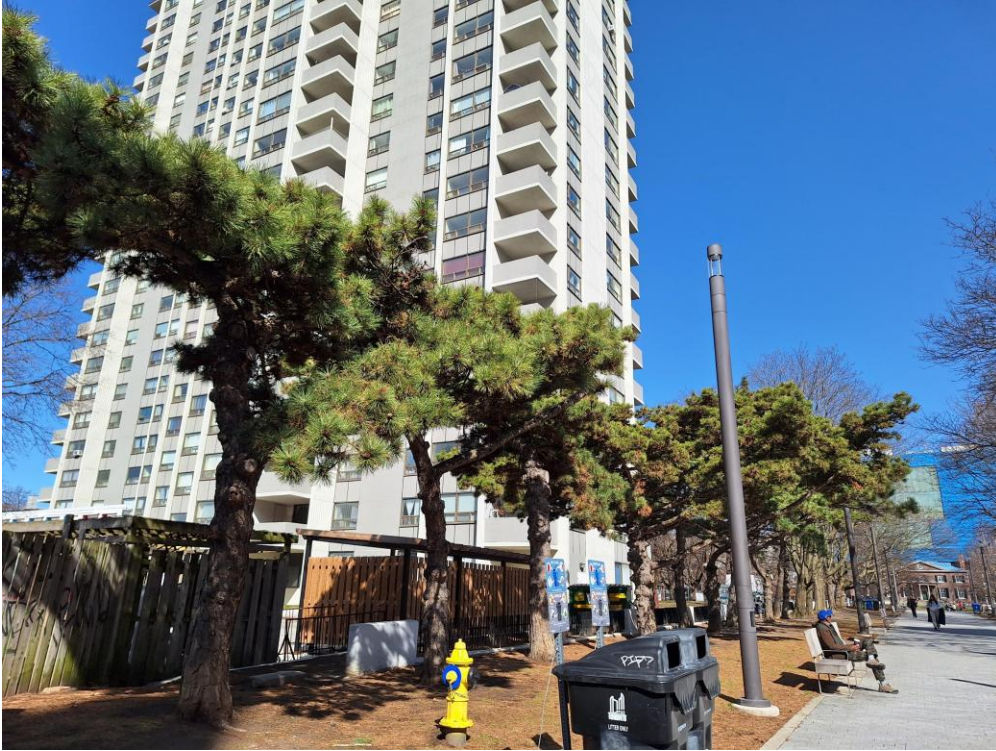
Image 1. Trees A-J

Encroachment into the mTPZs of Trees A-Q is required to accommodate a proposed curb. The following mitigation measures must be implemented prior to construction to ensure the trees respond well to construction:

The existing retaining wall/fence must remain in place and will serve as adequate tree protection hoarding.

1. AirSpade technology must be utilized to excavate a trench at the proposed excavation limits within the mTPZs of Trees A-Q as shown with a thick CYAN line on Figure 1.
2. Exposed roots are to be pruned within the trench in accordance with Good Arboricultural Standards.
3. If structural roots (greater than 5 cm in diameter) are encountered, work should stop immediately, and Urban Forestry contacted before any pruning occurs. While awaiting approval, exposed roots must be covered with damp burlap. If the City determines that cutting these roots could compromise the tree's structural integrity, the tree must be removed.
4. Once pruning is complete, the trench must be back filled with native material or clean loam soil.

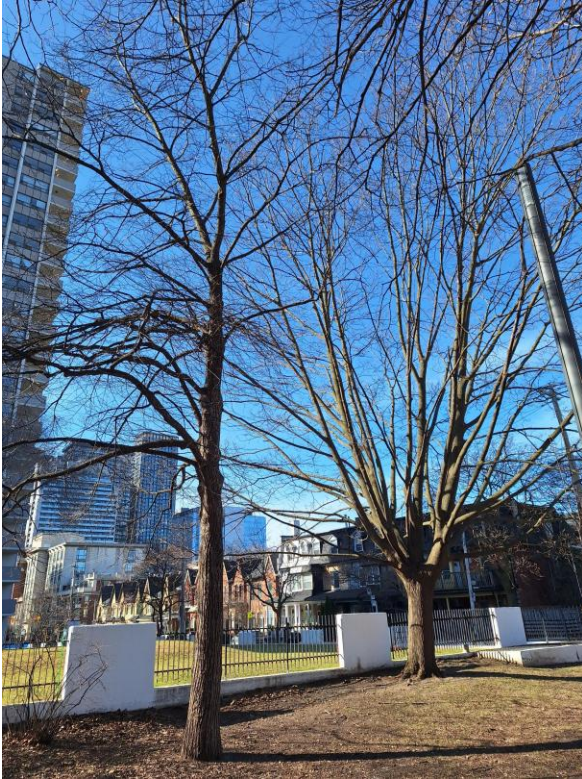
Image 3. Trees 901 and T

The removal of 21 trees including Trees 901-911 U-Z, and AA-CC will be required to accommodate the proposed development. Trees 904-911 directly conflict with the proposed building addition. Trees U-Z and AA-CC conflict with the removal of existing planters and proposed road widening. Significant encroachment into the minimum tree protection zones (mTPZ) of Trees 901-903 will be required to accommodate the removal of an existing retaining wall and underground parking lot such that the trees would not be expected to tolerate the resulting injuries.

Trees 901-911 are located on the subject property and are greater than 30 cm DBH (Category 1). Trees U-Z, and AA-CC are located within the right-of-way. A permit is required prior to the removal of these trees.
